SPECIAL COUNCIL MEETING 31 January 2022

| Item 5.2 – Narembeen Hall Refurbishment Tender 05/2021 - Scope of Works | 3 |
|---|---|
| Item 5.3 – Old Church Museum Refurbishment Tender 06/2021 | |

ATTACHMENT – AGENDA ITEM 5.2 Narembeen Hall Refurbishment Tender 05/2021 - Scope of Works

NAREMBEEN PUBLIC HALL 2A LONGHURST STREET, NAREMBEEN WA 6369

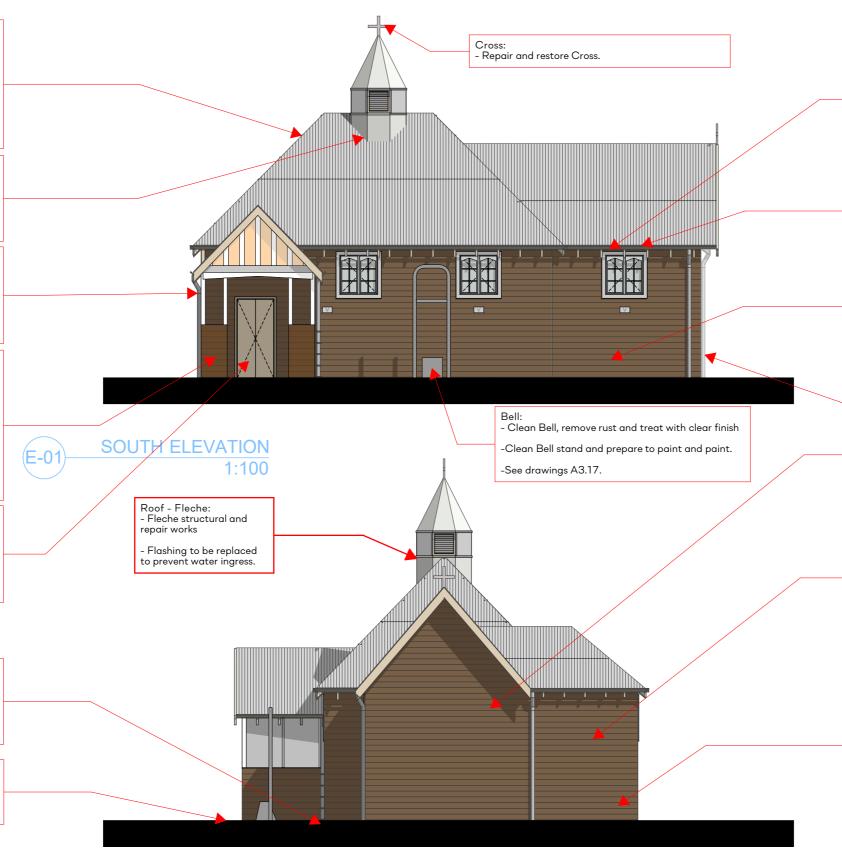
EAST ELEVATION

- All windows and doors to be repaired, prepared to paint and
- Glazing to be replaced where required.
- -Hardware to be replaced to match existing to make windows operable
- All existing curtains to windows to be removed and replaced with new. New curtains to match existing.
- Weatherstrip tape to all windows to prevent dust from entering the building
- -See drawings A3.12 to A3.14.

Bird Proofing:
- All bird proofing to be refixed and where required replaced.

-Loose or missing weatherboards to be replaced with boards to match the existing timber and profile.

- -The South elevation required replacement of 4 weatherboards running the full length of the elevation.
- Deteriorated fixings are to be replaced.
- All boards are to be cleaned, lightly sanded and oiled/painted for protection.
- See drawing A3.25.

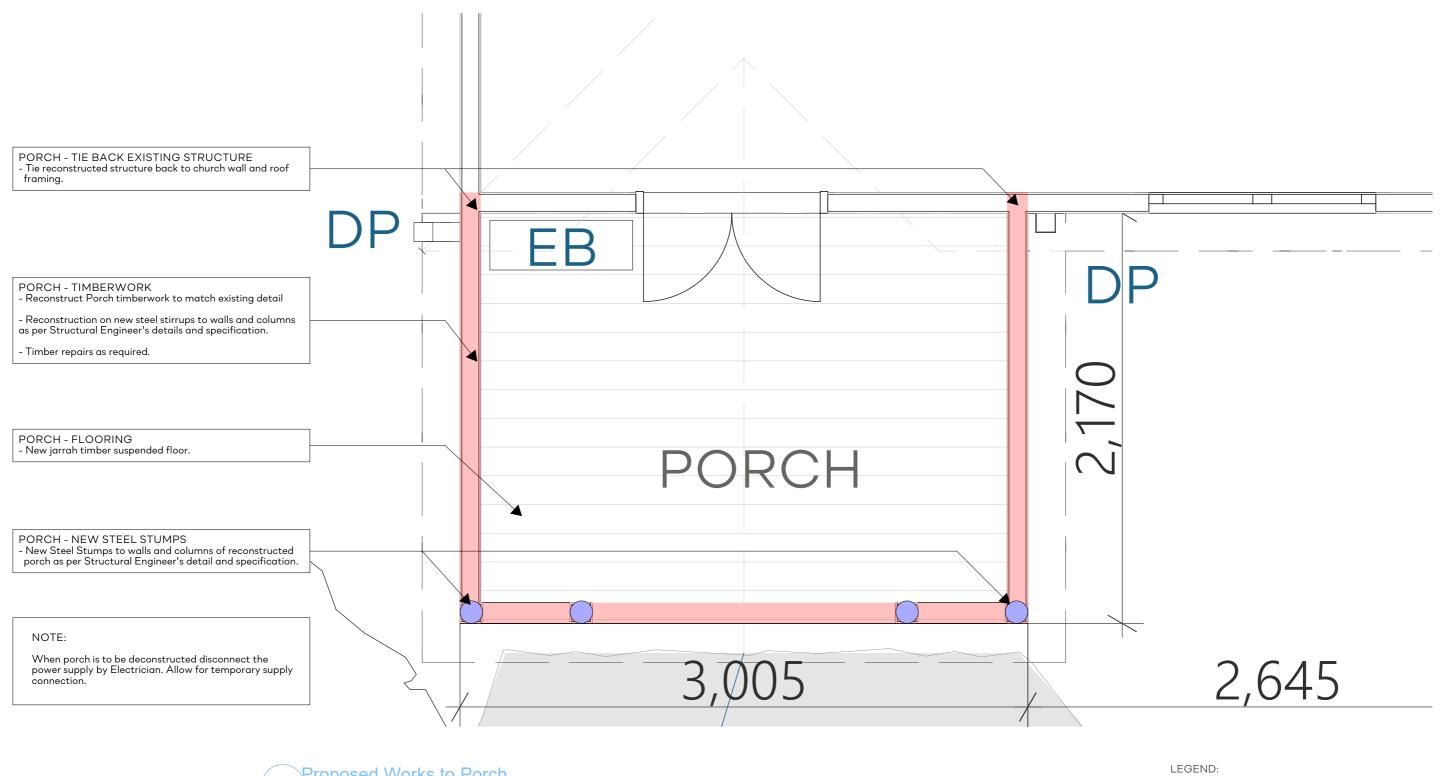
Proposed Works to Porch 1:20

- Asbestos sheeting to be removed and replaced with compressed fibre cement.
- Remove existing concrete slab and lower ground to min 100mm below bottom weatherboard.
- Porch finished level to be the same level as Church main floor level.
- Electrical Board to be retained.
- See drawings A3.18 & A3.19.

- When porch is to be deconstructed disconnect the power supply by Electrician. Allow for temporary supply
- Refer to Drawings, Specification and Schedules for further details.

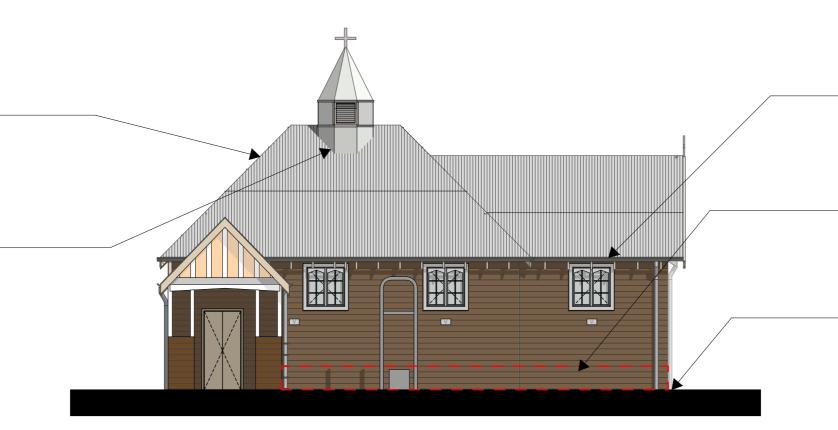
- ROOF STRUCTURE RE-SHEETING
 Existing roof sheeting to all roofs to be replaced with new galvanised corrugated sheeting.
- New roof sheeting profile and colour to match existing roof sheeting.
- -FX-21 See Schedules.

- ROOF SHEETING:
 Cut roof sheetig to allow for Fleche. Flash and cover flash to junction of fleche and roof.
- See drawings A3.16.
- Refer to Structural Engineer's drawings for further details.

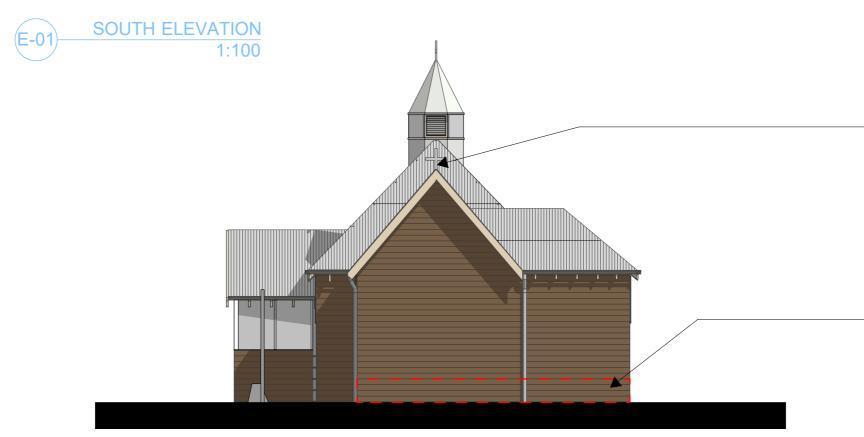
ROOF - CROSS

-Repair and restore cross to east elevation gable

-Repair and restore cross.

-Loose or missing weatherboards to be replaced with boards to match the existing timber and profile.

-Allow for 4 lengths of board for the whole elevation for replacement.

- Deteriorated fixings are to be replaced.
- All boards are to be cleaned, lightly sanded and oiled/painted for protection.

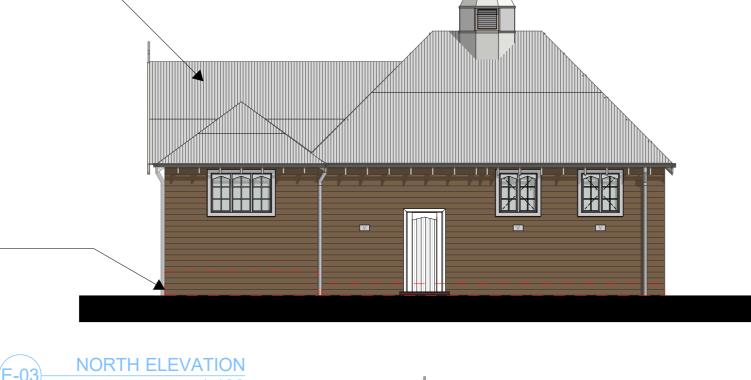
External Walls:

-Loose or missing weatherboards to be replaced with boards to match the existing timber and profile.

- -Allow for 8 linear meters of replacement to north corner to bottom weatherboards.
- -Loose or missing fixings are to be replaced with galvanised
- All boards are to be cleaned, lightly sanded and oiled/painted.

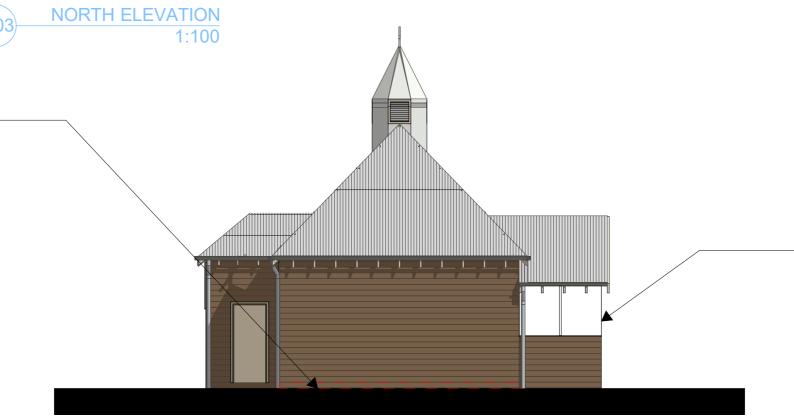
Entry Porch:

- Reconstruct entry porch to existing detail

-Asbestos sheeting to be removed and replaced with compressed fibre cement.

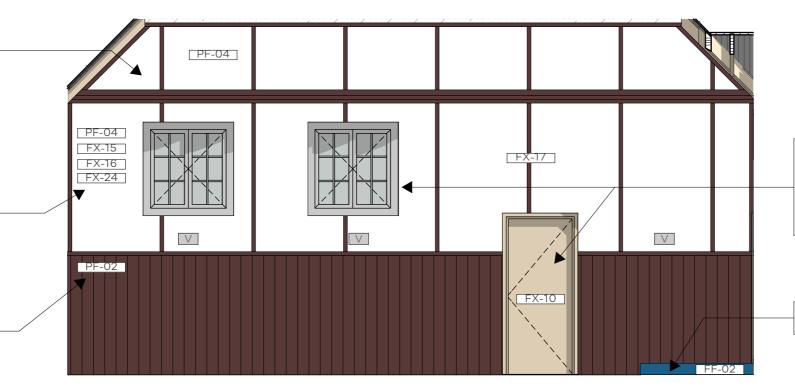
INTERNAL ELEVATION 01

- Existing plasterboard sheets to be removed with new.
- Install thermal insulation and waterproof membranes to internal walls.
- New internal walls to be cleaned, prepared to paint and painted. Paint to match existing.
- -Existing cover battens to be removed and replaced with new. New cover battens to match existing detail ~Approx. 46mmx10mm

- Existing windows and doors surrounds to be lightly sanded, prepared to paint and painted. Paint to match existing.

- Existing windows and doors hardware to be

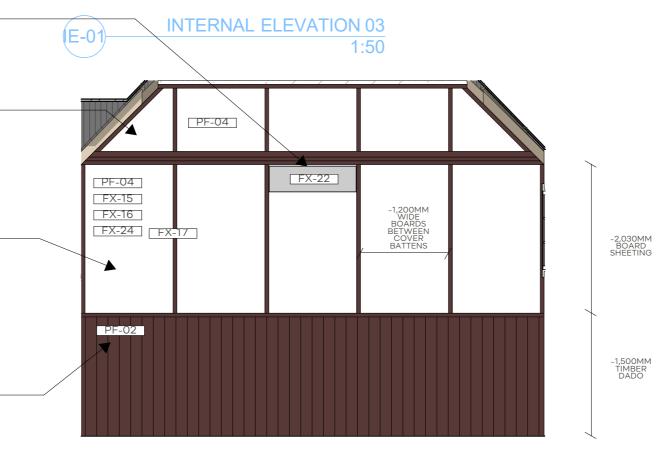
INTERNAL ELEVATION 04

TIMBER DADO

Existing timber dado to be lightly sanded, prepared to paint and painted - clear coat.

VENTS

Existing vents to be retained, cleaned

WINDOW + DOOR

- Existing windows and doors hardware to be repaired/replaced with new. New hardware to match existing. Refer to window and door schedule for finishes, fittings and fixtures.
- Existing windows and doors surrounds to be lightly sanded, prepared to paint and painted. Paint to match existing.

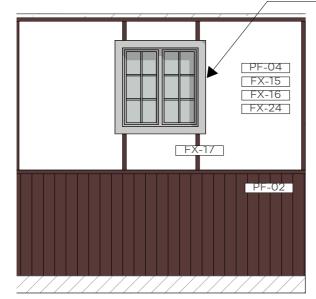
INTERNAL ELEVATION 03

- Existing plasterboard sheets to be removed with new.
- Install thermal insulation and waterproof membrane to internal walls.
- New internal walls to be cleaned, prepared to paint and painted. Paint to match existing.
- -Existing cover battens to be removed and replaced with new. New cover battens to match existing detail ~Approx. 46mmx10mm

WINDOW + DOOR

- Existing windows and doors hardware to be repaired/replaced with new. New hardware to match existing. Refer to window and door schedule for finishes, fittings and fixtures.
- Existing windows and doors surrounds to be lightly sanded, prepared to paint and painted. Paint to match existing.
